# Home Inspection Report

Inspection Address:  
**Sample Report, CA**

Prepared By:  
**20/20 Home  
Inspections  
319 Balboa Ave.  
Davis, CA 95616**

Inspector:  
**Craig Eden**  
National Association of  
Certified Home Inspectors  
Member # NACHI02043001

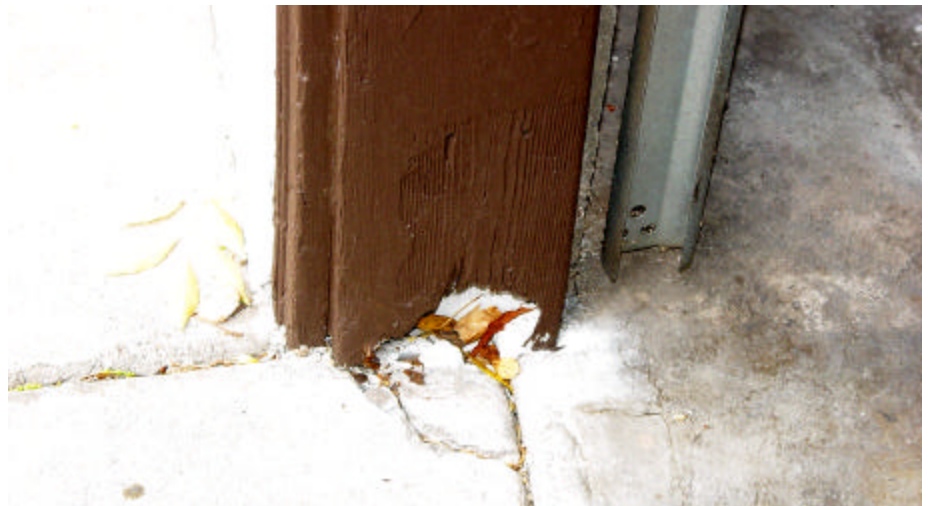
Exterior trim at the lower left corner of the garage door was deteriorated. The deteriorated trim should be carefully examined, then repaired or replaced as necessary to assure continued service. In the future, it should receive regular maintenance.

1. Exterior trim at the lower left front corner of the garage door was deteriorated. All deteriorated trim should be carefully examined, then repaired or replaced as necessary to assure continued service. In the future, it should receive regular maintenance.

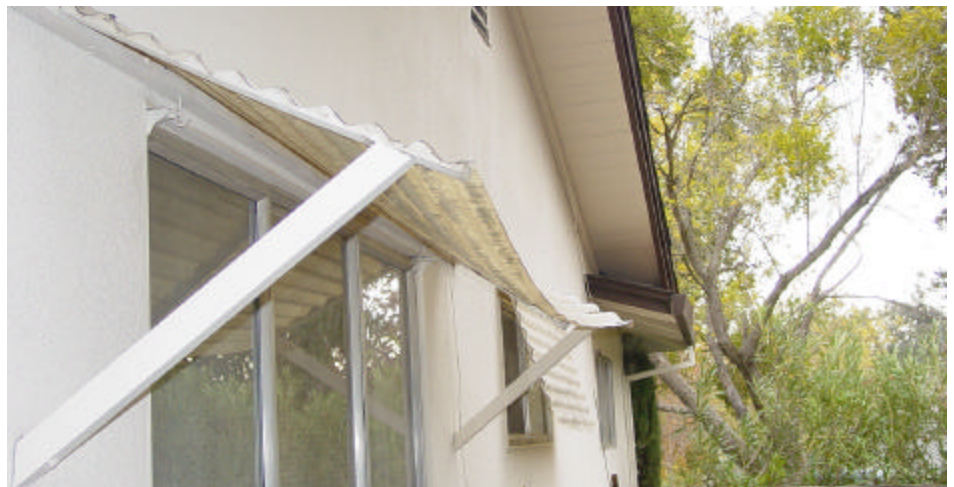
The window covers were seriously deteriorated and in need of replacement. The replacement covers should be installed in conformance with standard practice and/or the manufacturer's installation instructions.

2. The window covers were seriously deteriorated and in need of replacement. The replacement covers should be installed in conformance with standard practice and/or the manufacturer’s installation instructions.

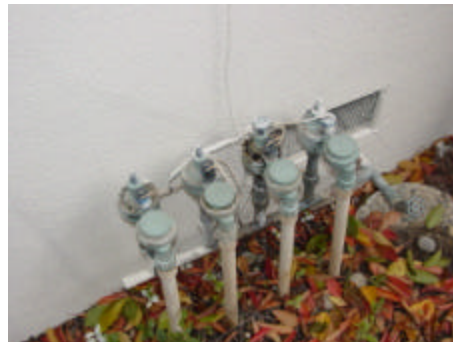
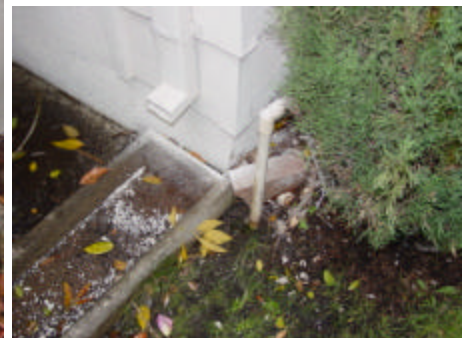
While testing of the yard irrigation system is beyond the scope of a home inspection, leaks were quite evident at several of the sprinkler valves. All leaking, malfunctioning or damaged sprinkler valves in the yard irrigation system should be repaired or replaced.

A PVC water supply at the exterior left front corner was damaged and in need of repair.

3. While testing of the yard irrigation system is beyond the scope of a home inspection, leaks were quite evident at several of the sprinkler valves. All leaking, malfunctioning or damaged sprinkler valves in the yard irrigation system should be repaired or replaced to ensure efficient operation of the irrigation system and to minimize wasteful water leakage.

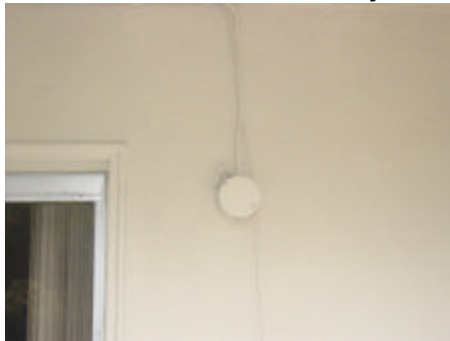
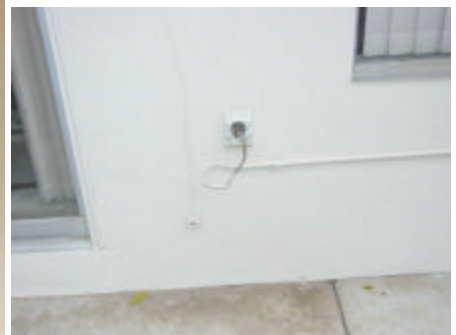
Improper wiring methods and techniques were observed at the exterior rear. Improperly installed wiring should be abandoned or removed and replaced with properly installed wiring certified to be safe and dependable by the competent, licensed electrician who performs the work.

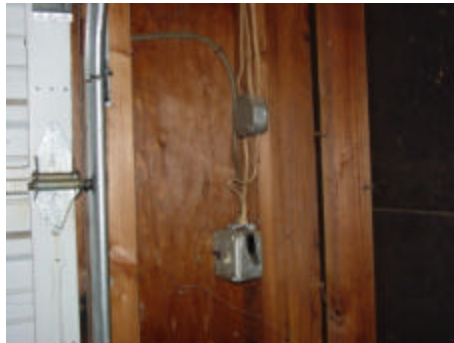
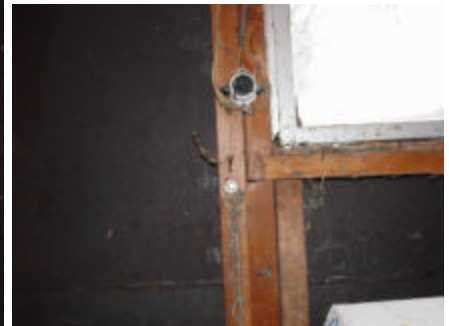
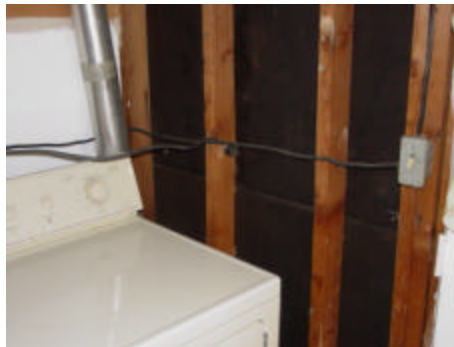
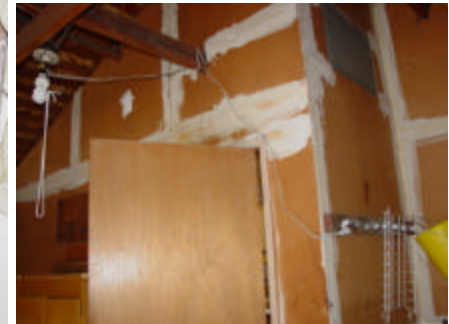
#### Examples:

Improper wiring techniques and methods were observed in the garage. Improperly installed wiring should be removed and replaced with new wiring installed in conformance with standard trade practices by a competent, licensed electrician.

7. Improper wiring methods and techniques were observed in the garage. Improperly installed wiring should be abandoned or removed and replaced with properly installed wiring certified to be safe and dependable by the competent, licensed electrician who performs the work.
8. Improper wiring techniques and methods were observed at the exterior rear. Improperly installed wiring should be removed and replaced with new wiring installed in conformance with standard trade practices by a competent, licensed electrician.

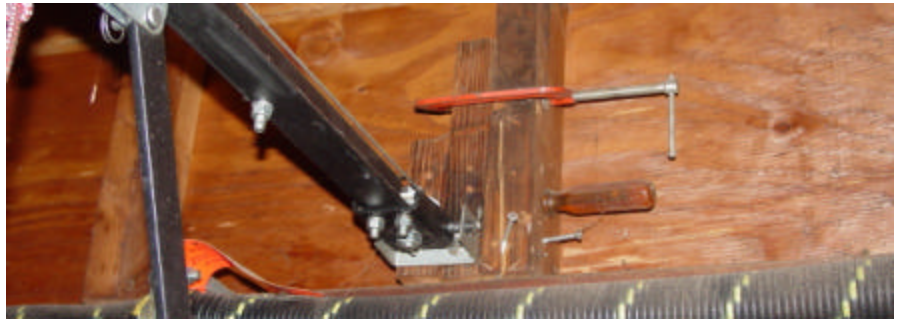
The garage door opener had been installed in a substandard manner. A competent garage door technician should examine the garage door opener and re-install the opener as appropriate.

4. The garage door had been installed in a substandard manner. A competent garage door technician should examine the garage door and replace all missing hardware, tighten all fasteners and adjust any counterbalance mechanism or completely re-install the door, as appropriate, to restore the door to peak operating condition.

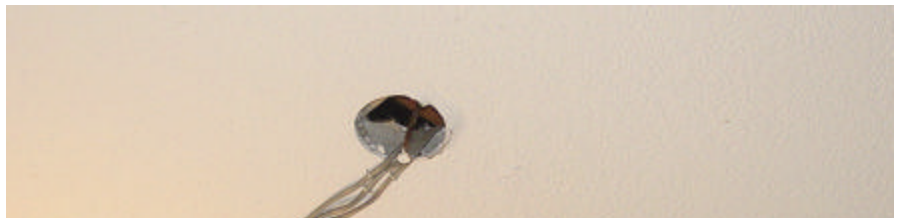
### Fire Separation between the House and the Garage

5. Voids were evident in the fire resistive barrier between the garage and the interior. We recommend that these voids be patched to restore the required fire separation between the garage and the occupied interior.

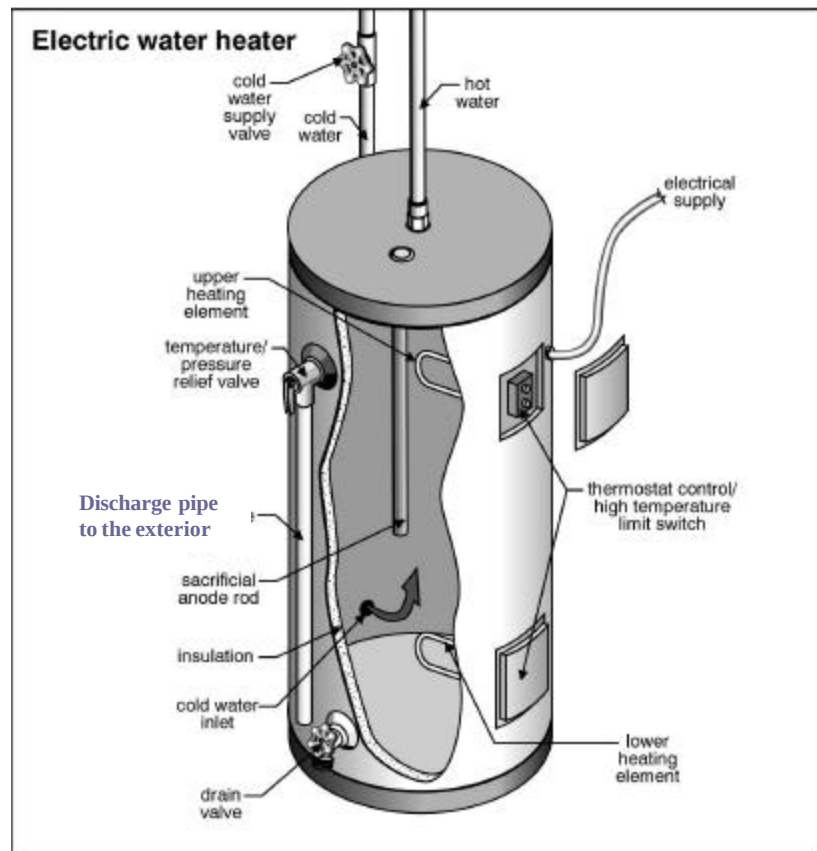
### Temperature and Pressure Relief Valve

16. A PVC water supply at the exterior left front corner was damaged and in need of repair.
17. The installation of the temperature and pressure relief valve for the water heater did not include a discharge pipe. A discharge pipe, conforming to the relief valve manufacturers specifications and local requirements, should be installed so as to exit at an approved location.

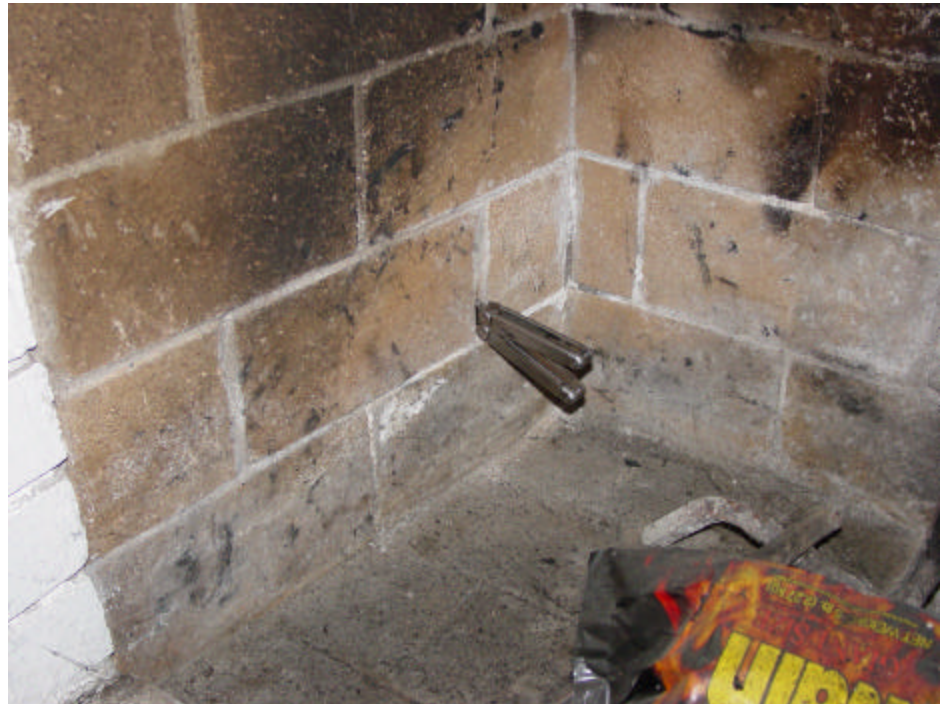
The mortar in the firebox of the fireplace was soft, and mortar was missing from around the bricks. All loose mortar in the firebox should be removed and new mortar installed. This is known as "tuck pointing."

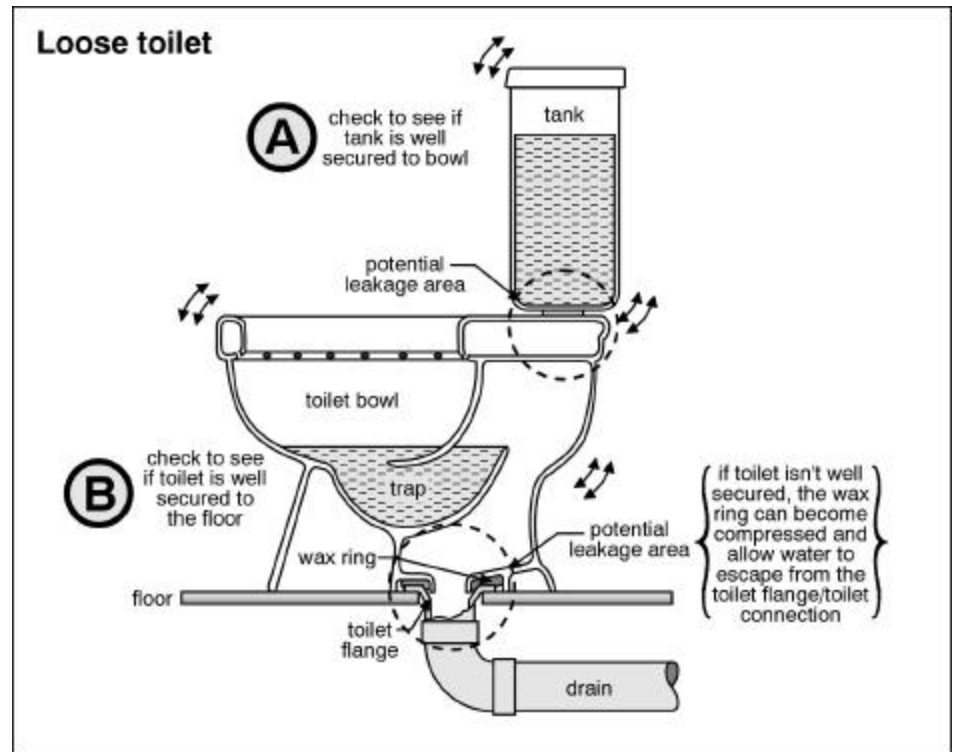
The master bathroom toilet was not securely attached to the soil pipe flange at the floor. A competent, licensed plumber should remove the toilet, inspect the floor for damage, and after repair of any floor damage, reset the toilet, securely to the floor, using a new bowl wax.
